DNA Analysis of Building

Address Garðaskóli

Case nr. 3.161.348

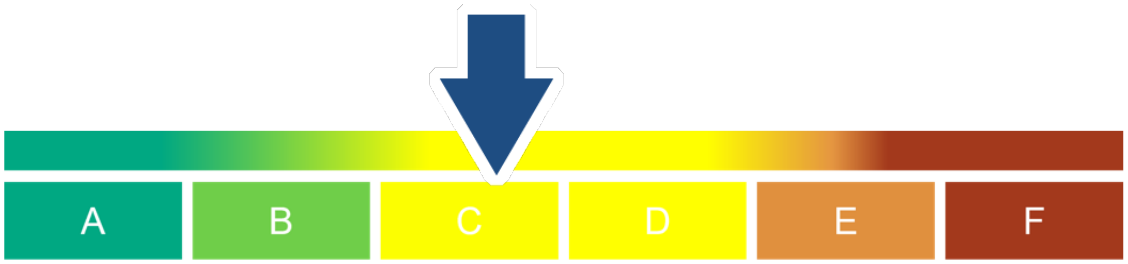
7723 Garðaskóli
1 hæð. Stjórnin fundahebergi, 435

Based on the analysis results for the test made from 1 hæð. Stjórnin fundahebergi, Garðaskóli, our evaluation is that the rate of mould in the building is somehow above the normal, expected level for dry, clean and undamaged buildings. When looking at the composition of mould species there is no sign of a severe or long-lasting moisture damage. The slightly increased level of total mould is primarily attributed to accumulation in dust by outdoor species. However, there is an increased level of *Penicillium* and *Aspergillus*, which may originate from a small moisture damage with low moisture levels, as e.g. condensation on a thermal bridge.

We recommend to dry off horizontal surfaces and to vacuum with a HEPA filter.

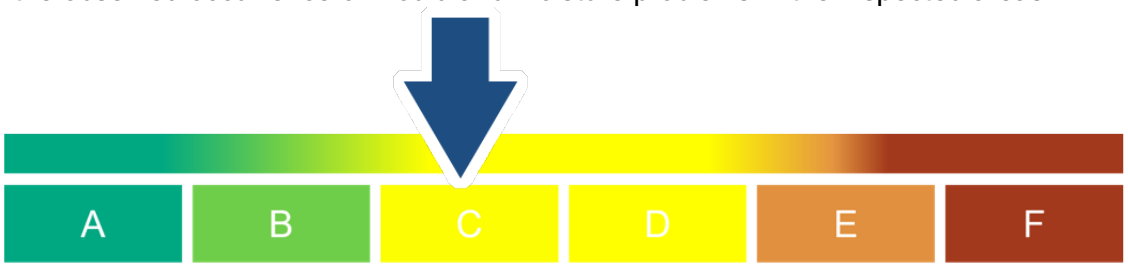
7730 Garðaskóli
2 hæð. Vinnuherbergi Kennara íslenska, 387

Based on the analysis results for the test made from 2 hæð. Vinnuherbergi Kennara íslenska, Garðaskóli, our evaluation is that the rate of mould in the building is somehow above the normal, expected level for dry, clean and undamaged buildings. The presence of *Aspergillus* and *Penicillium* often observed in buildings with moisture and water damages is far above normal level. There is an increased level of *Aspergillus glaucus* in the test.

As a whole our evaluation is that the zone is affected by atypical levels of microbiologic material.
